Late polyethylene liner dissociation after cement-free hip joint replacement: A case report

Case Report: Here we report a case of 67-year-old male who presented with hip pain after bending forward. Polyethylene liner dissociation was found at urgent revision surgery that was not diagnosable by imaging alone.

Almaimani G, Schreyer C. Late polyethylene liner dissociation after cement-free hip joint replacement: A case report. Int J Case Rep Images 2016;7(12):832–835.

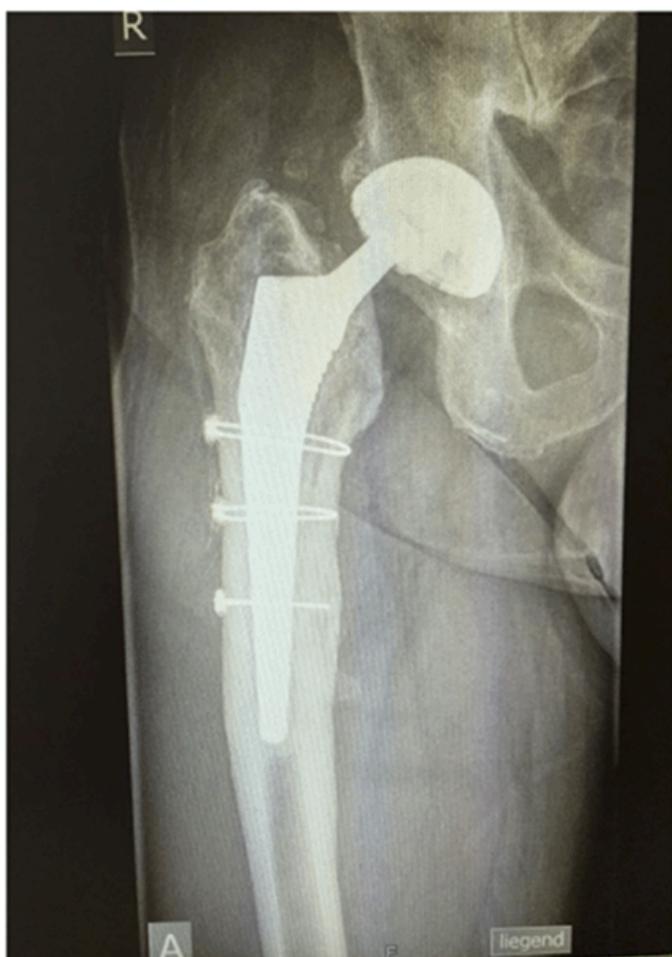
No significant limb length discrepancy or neurovascular deficit was noted, but the range of hip joint motion was limited by pain. His body mass index was 25.9 kg/m². There was no history of previous right hip dislocation. A radiograph showed that the femoral head was clearly and eccentrically displaced within the acetabular component (Figure 1). There was no apparent loosening of the THA components or signs of secondary fracture. Fracture of the ceramic head or polyethylene liner was suspected.

Figure 1: Preoperative anteroposterior radiograph showing a clearly eccentric head of the femoral prosthesis within the acetabular component. The polyethylene liner cannot be seen.

The patient was scheduled for urgent revision surgery. At operation, the polyethylene liner was seen to have completely dissociated from the shell and was displaced from the outer shell. There were no macroscopic signs of metal debris or metallosis. Both the femoral component and the acetabular socket were stable. The acetabular cup was revised with a 56/32 mm Marathon highly cross-linked polyethylene liner and a 32 mm stainless steel long

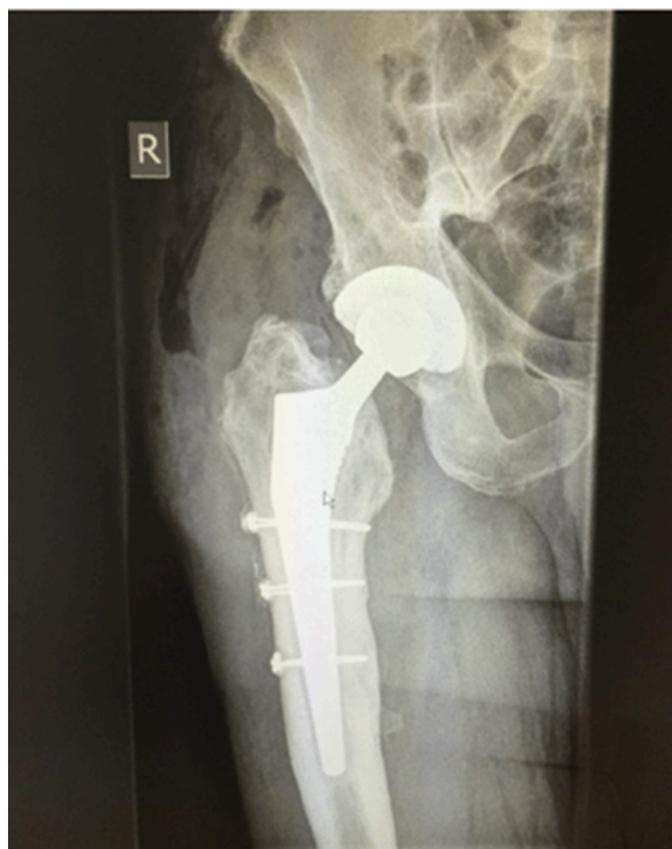
Figure 2: Postoperative radiograph showing good prosthesis positioning, with the head of the femoral prosthesis located centrally within the acetabular component.

neck femoral head (DePuy, Warsaw, IN). The femoral component was not revised. Postoperatively, he was maintained on partial weight bearing for four weeks. His inpatient stay was uncomplicated and he was discharged on postoperative day-7. A postoperative radiograph showed no abnormality (Figure 2). He reported no hip joint pain and he was fully ambulatory at his most recent outpatient follow-up appointment.
