CASE REPORT

Fracture through a femoral stem prosthesis after trauma: A case report and review of the literature

R. F. Lyons, C. G. Murphy

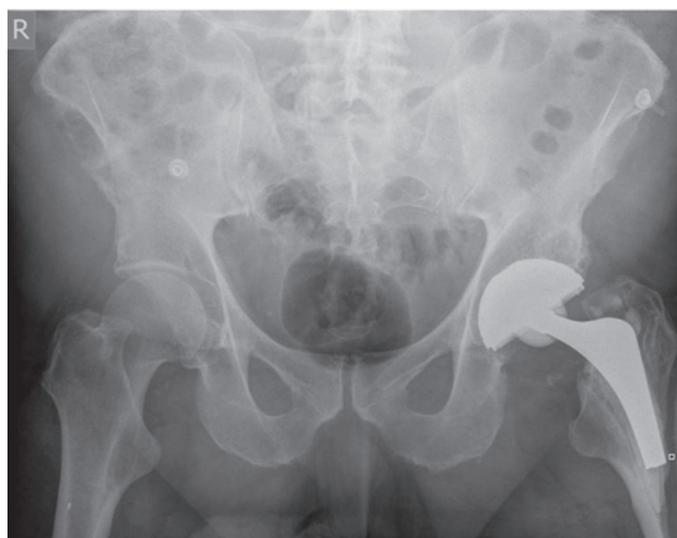
Figure 1: Anterio-posterior pelvis pre-operative X-ray (TIFF).

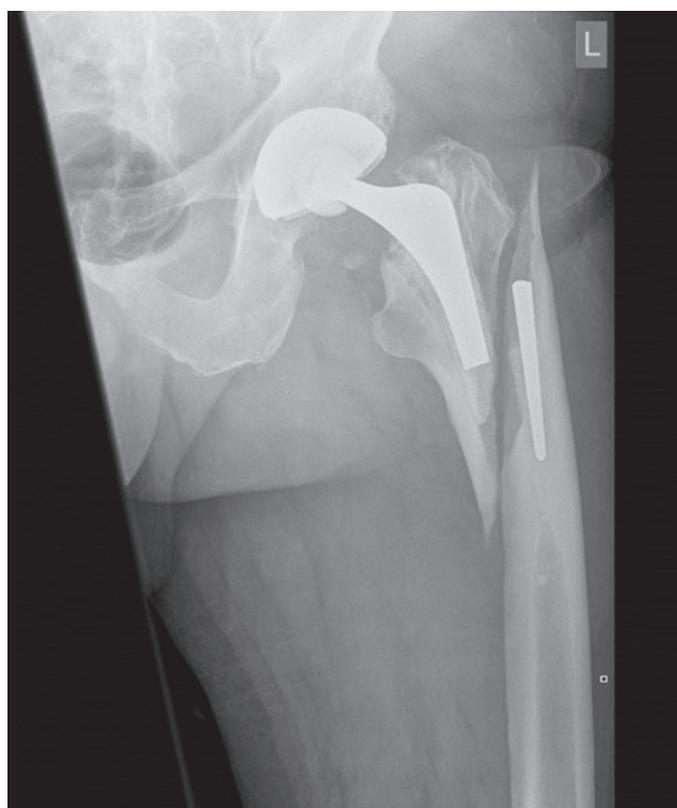
Figure 2: Pre-operative full length femur X-ray (TIFF).

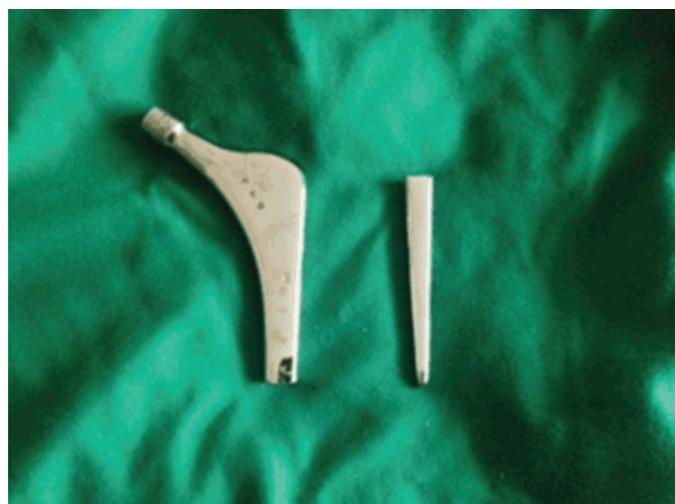
A posterior approach to the hip was undertaken for revision. Intraoperatively good bone stock was noted. The fracture site was identified with no further distal extension of the fracture noted. The bone-cement and prosthesis-cement interface were intact. The proximal components were well fixed in cement. No loosening of the prosthesis was appreciated. The proximal component was removed using drilled Kirchner (K-wires) wires, followed by flexible and rigid osteotomes. An osteotomy was not utilised. The distal component was similarly well fixed in cement and both the prosthesis fragment and the cement were removed again using a combination of sequential K-wires, flexible and rigid osteotomes, and a metallic burr to bypass the cement restrictor and plug. The acetabular cup was assessed and found to be stable and compatible with the new implant configuration so was left in situ.

Figure 3: Fractured implant (TIFF).

In this case, both the proximal and distal segments were adequately cemented in place, hence eliminating cantilever bending forces as a mechanism for failure. There was no issue at the level of the bone-cement interface or the prosthesis-cement interface, suggesting that the cementing technique was adequate. Poor cementing technique has been hypothesised as a risk

factor for implant failure and fracture. However due to the intact cement mantels it would appear as an unlikely factor in the implant failure in this case [4]. To the best of our knowledge this is the first report of femoral stem fracture secondary to trauma with no compounding factors of loosening, infection or cantilever forces causing fatigue.

Cerclage wires were used to reduce the femoral fracture. The distal femur was prepared with a reamer and a fully HA-coated dual offset collared uncemented stem was used, bypassing the fracture site. This was supplemented with a trochanteric grip plate. Figure 3 shows the fractured stem and Figure 4 is a radiograph of the post operative revision implant in place. The patient was mobilised on the day following surgery with protected weightbearing for six weeks following surgery.

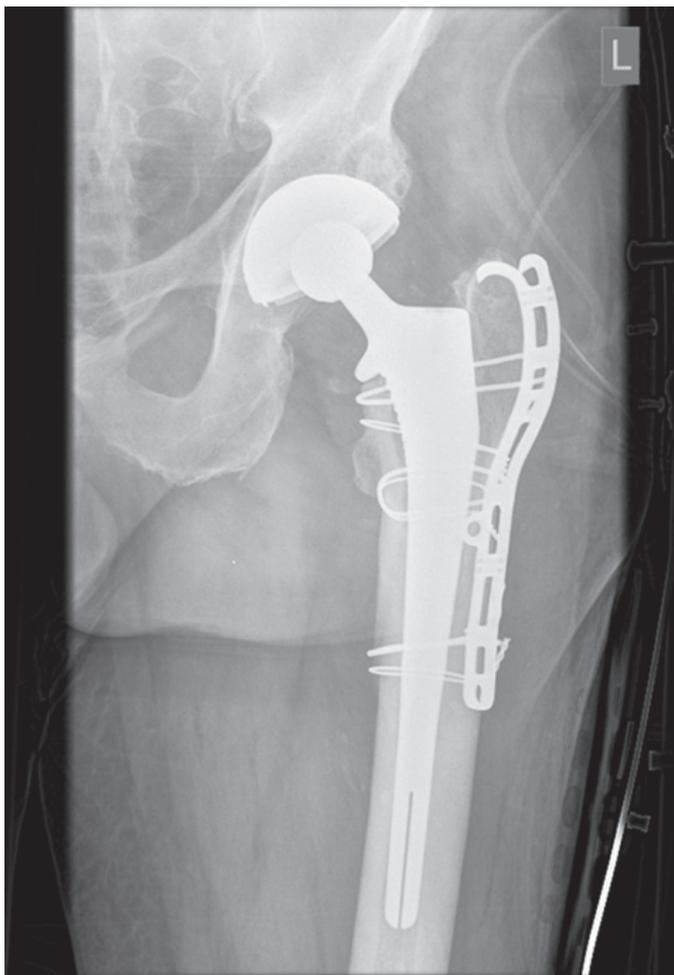
Figure 4: Post operative revision X-ray (TIFF).
