Fracture in the middle of the femoral stem and relevant treatment after the revision total hip arthroplasty: A case report

Case Report: Here we report the case of a 63-year-old man, who complained of sudden pain in the right lower limb thigh and was subjected to stem failure without obvious inducement after revision total hip arthroplasty. The patient was discharged from the hospital after undergoing relevant revision surgery, and was satisfied with the recovery at the 1-year follow-up.

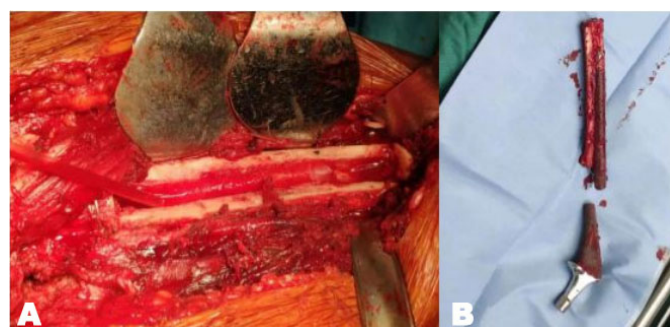
Figure 2: (A) The remaining part of the femur after fenestration with an intraoperative; (B) Proximal prosthesis and distal prosthesis attached to the fenestrated femoral portion individually.

fully flexed, adducted, and rotate to achieve dislocation. After decoupling the femoral head, it was found that the acetabular cup was well-fixed, and there was no evidence of polyethylene linear wear. Therefore, the part of the acetabulum was retained. Owing to proximal loosening of the femur, the femoral component was detached with a series of impacting and extracting blows using pincers. Moreover, the distal femoral prosthesis was challenging to be directly dissected out of the medullary cavity owing to its close connection with the bone tissue. It was, therefore, necessary to extend the original incision to the middle of the femur, perform extended trochanteric osteotomy (ETO) at the upper half of the femur using an ultrasonic osteotome, and then excise it using the distal prosthesis (Figure 2). The prosthesis was slightly separated from the bone tissue using an osteotome, and then the freeing bone fragments were reattached to the femur with five cerclage wires. After the medullary cavity was reamed using a power system, the inserted femoral stem (standard non-collared CORAIL Stem, DePuy Synthes, SZ 13) was driven with a tilt of 15° anteversion angle, and the short-necked femoral head prosthesis (BIOLOX delta Ceramic Heads, DePuy Synthes, 32 mm–12/14+1) was replaced. Then, the femoral reconstruction was completed. The limb movement was normal after reduction, and the incision was sutured layer by layer.

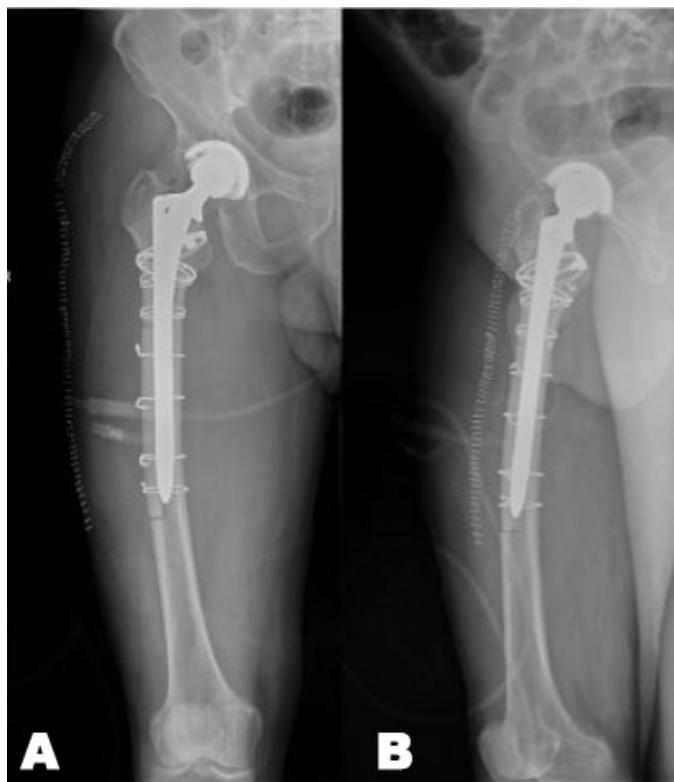
Figure 3: (A) and (B) Radiological examinations of the right femur after operation. It is suggested that the prosthesis is closely attached to the marrow cavity at an appropriate position.

A “T” shoe was fixed to his right lower extremity post-surgery and low-molecular-weight heparins calcium was intravenously injected every 12 hours to prevent thrombosis. Reexamination of postoperative radiograph demonstrated that the prosthesis was in place and the bone fragment after osteotomy was well aligned (Figure 3). Waiting for the general situation to stabilize, the patient was permitted to leave the hospital, and he was required to stay in bed strictly for two months. At subsequent follow-up, the patient was satisfied and pain-free.
